**SAS Superstructure**

Location: 04-SF-80-13.2 / 13.9

**Daily Diary Report by Bid Item**

Diary #: 205 Const Calendar Day: 305 Date: 05-Apr-2013 Friday

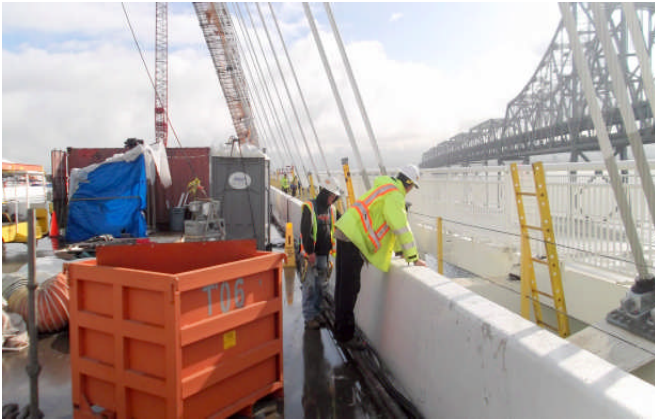
Rex & Charlie (METS) watched painters cleaning the bottom of rope area for caulking

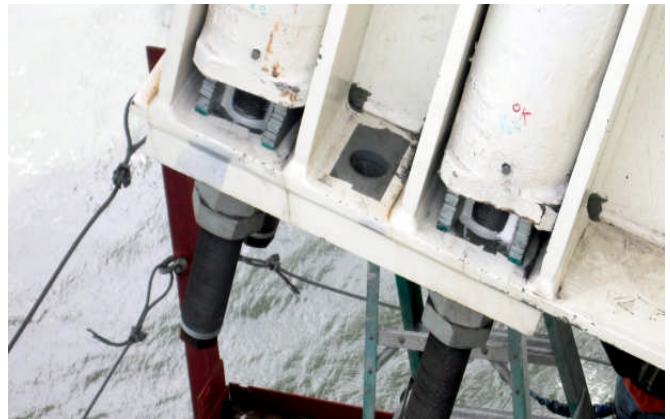
Bottom of Rod caulking with sim plates

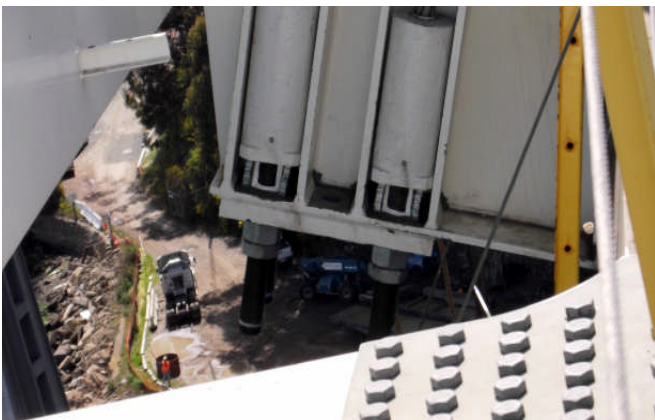
Another view for rod caulking to sim plates

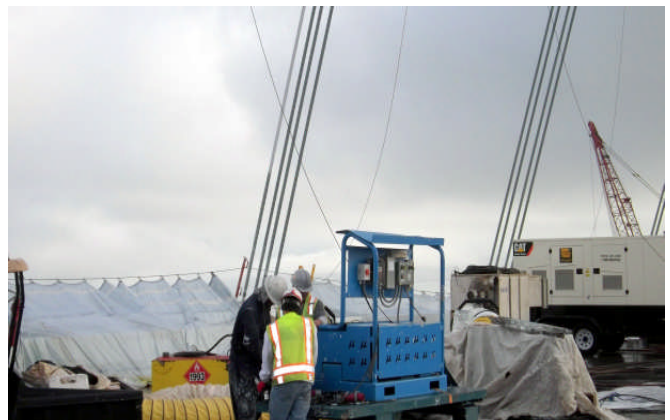
Painters were cleaning equipment including air ducts at N80 area

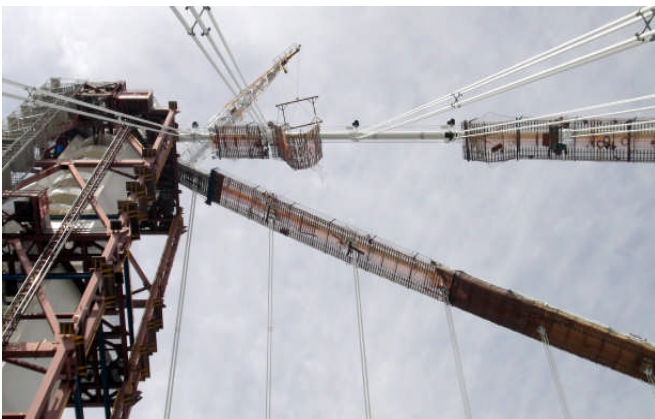
IRW's removed catwalk at SMS area

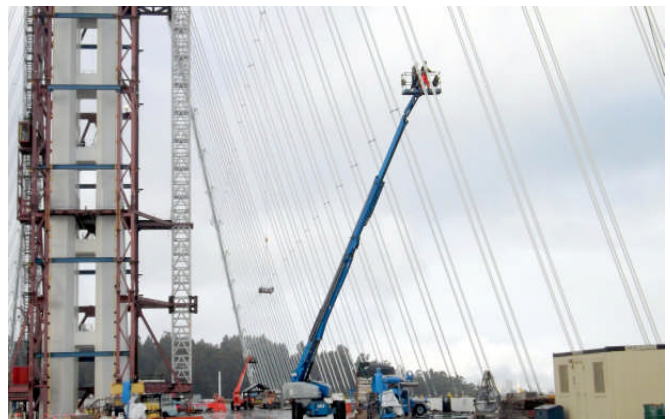
Crew were installing separators from N64 to N74

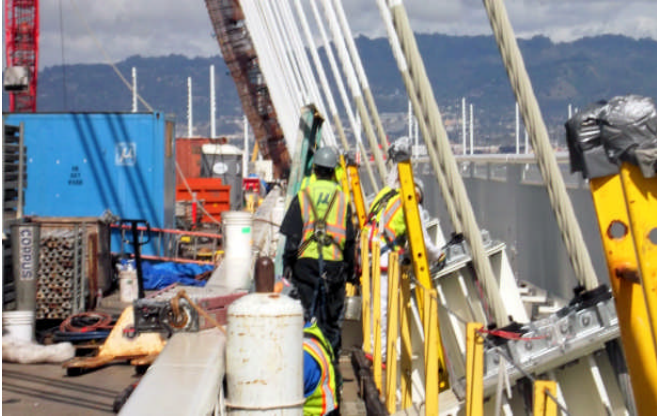
Total 8 painters worked on caulking at south main span area

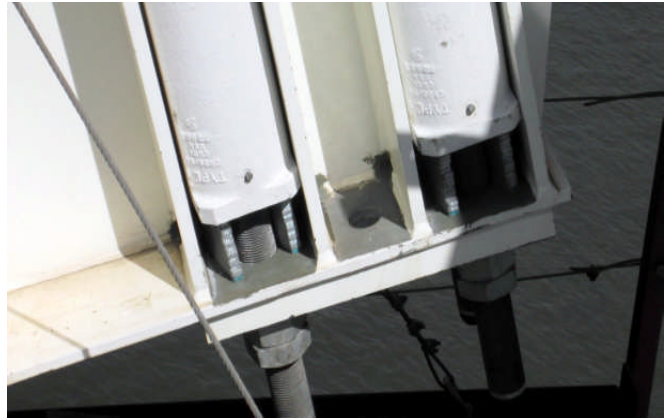
- \* Operation finished at 5:00 PM, crew finished top plate caulking from S78 to S96; S8-S6 top & bottom caulking finished, S62 to S72 were not finished due to wet area obtained from power wash on the main cable (area from S58 to S70).

Bottom Rod without caulking to sim plates

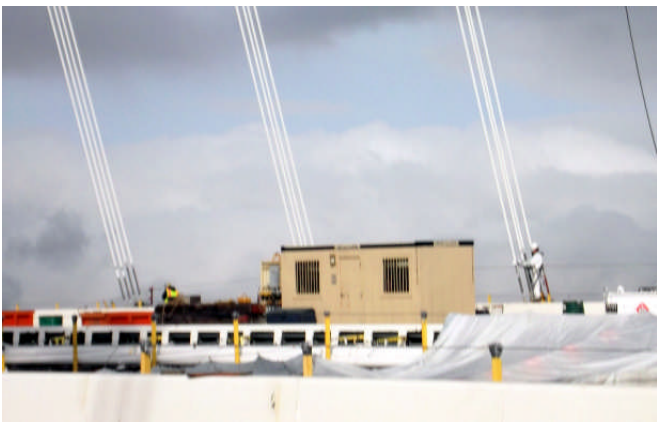
Three painters performed cleaning bottom of suspender ropes at N76 to N84 area

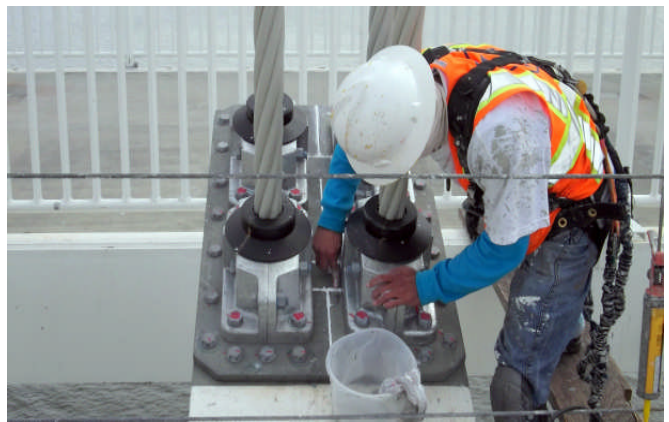
Painter performed caulking on top suspender bracket
